Intel® Pentium® Processor N3500-series, J2850, J2900 and Intel® Celeron® Processor N2900-series, N2800-series, J1800-series, J1900, J1750

Specification Update

April 2019

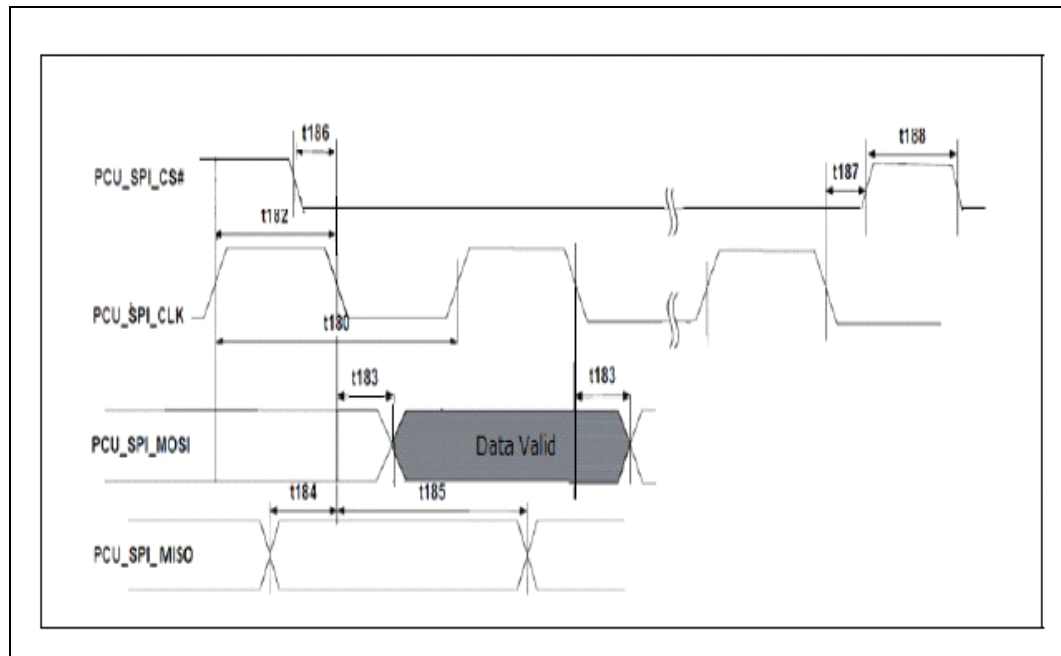
Figure 65. SPI NOR Timing
